WATSON HOME INSPECTION SERVICES LLC

WATSON - RESIDENTIAL V2.0

1234 Main Street
Phillipsburg, NJ 08865

11/27/2023 9:00AM

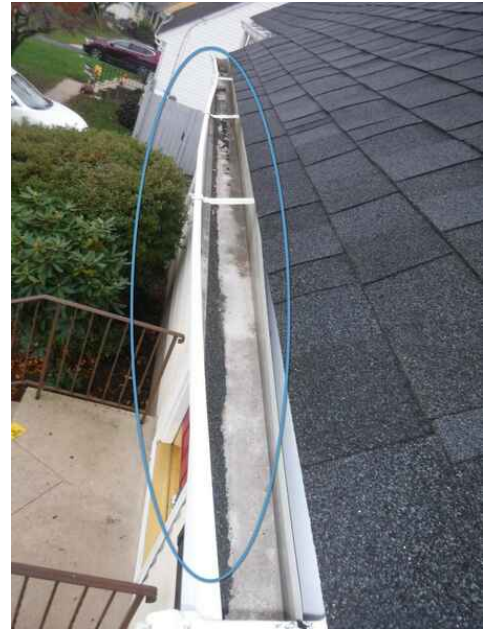
One or more areas of the gutter system had visible debris (granules). This could result in the gutters not being able to properly carry water away from the house resulting in water damage and possible water intrusion. Recommend cleaning of the gutter system by a licensed contractor.

Contact a qualified professional.

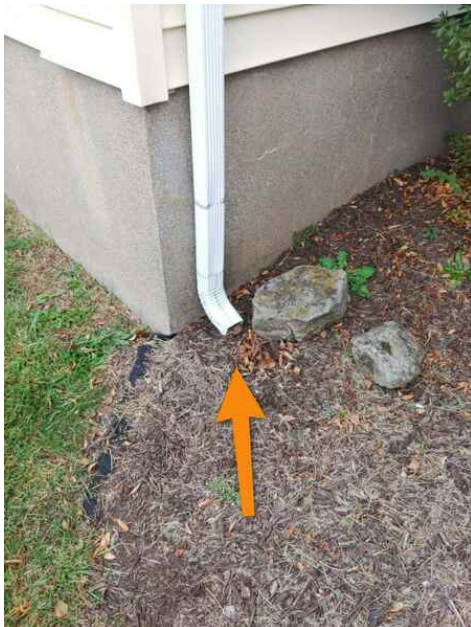
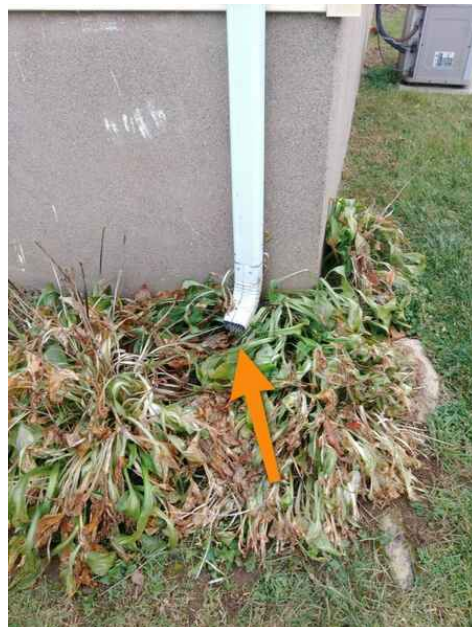
2.3.2 Roof Drainage Systems

DOWNSPOUTS DRAIN NEAR HOUSE

One or more downspouts was draining too close to the home. Water can accumulate around the building foundation or inside crawlspaces or basements as a result. Recommend that a licensed contractor install, replace or repair extensions as necessary, so rainwater drains away from the structure.

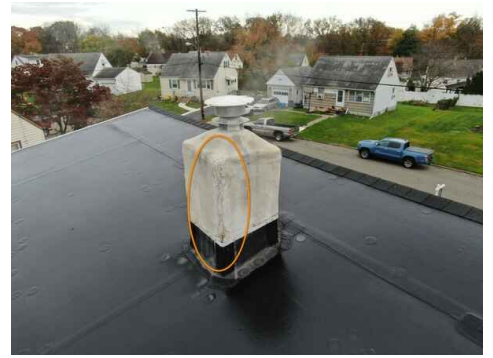
2.5.1 Skylights, Chimneys & Other Roof Penetrations

PARGE COAT CRACKING

One or more cracks were observed in the masonry parge coating on the chimney. The inspector recommends further evaluation and repair by a licensed chimney specialist or a licensed masonry contractor.

Contact a qualified masonry professional.

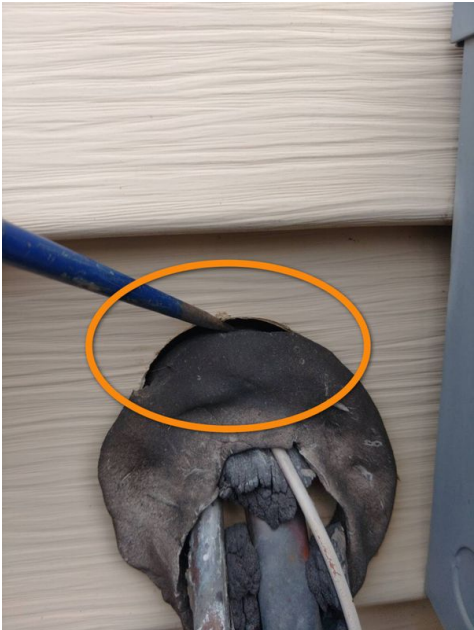
One of more wall penetrations and/or gaps were not sealed properly. This could lead to moisture intrusion and damage to the underlayment and interior finishes of the home. Recommend having the hole repaired by a licensed contractor.

Contact a qualified professional.

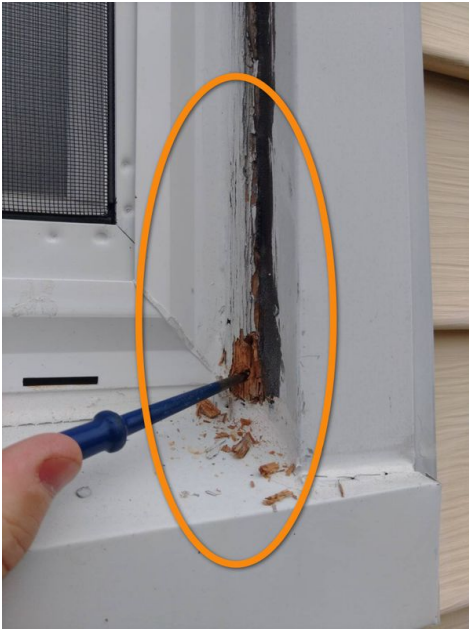
3.2.2 Siding, Flashing & Trim

WINDOW AND/OR DOOR TRIM ROT

One or more areas of window and/or door trim were rotting. This could lead to moisture intrusion, resulting in damage to the sheathing and/or the interior finishes of the home. Recommend having the trim replaced by a licensed contractor.

Contact a qualified carpenter.

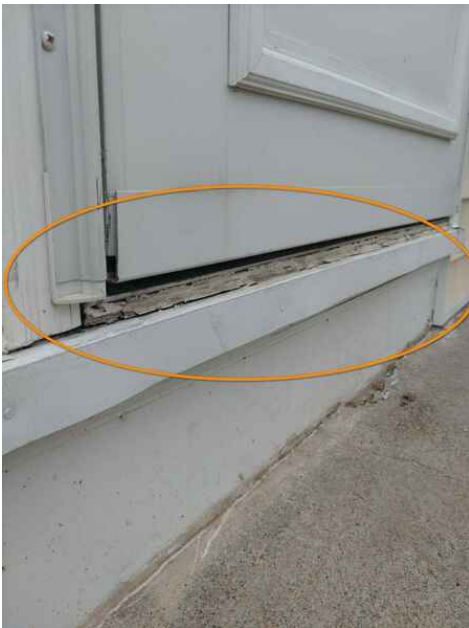
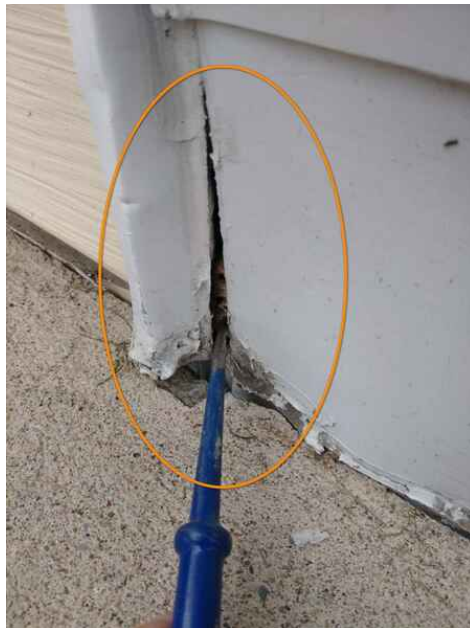
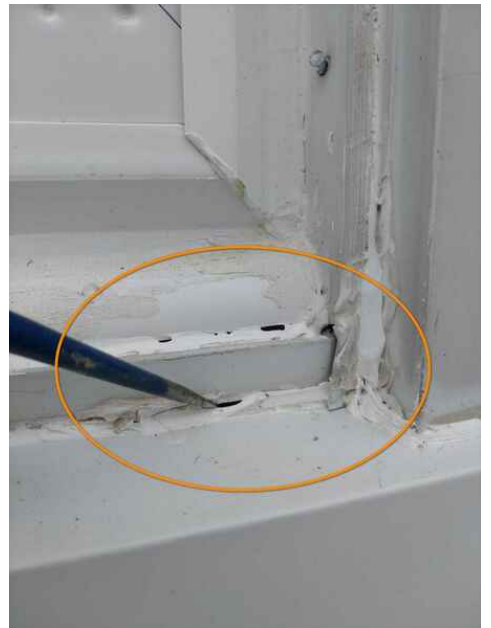
3.2.3 Siding, Flashing & Trim

DRIED/AGED/MISSING CAULK

One or more areas of caulk around a door/window or siding penetration were dried out and cracking or missing. This could result in moisture intrusion, damage to the interior finishes and possible mold/fungi growth. The inspector recommends having all affected windows re-caulked by a qualified contractor or handyman.

Contact a qualified professional.

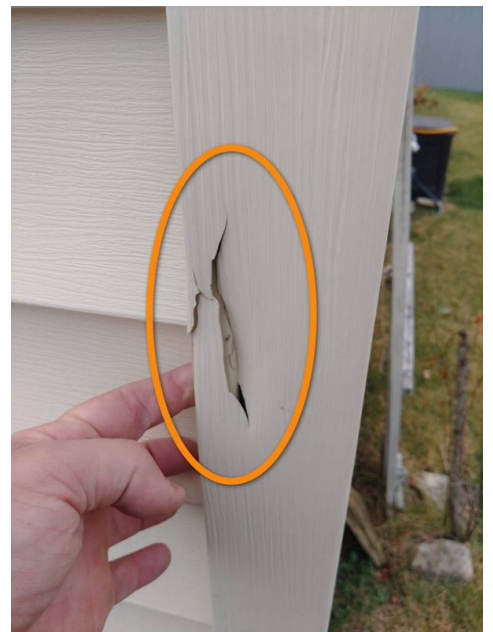
DAMAGED SIDING TRIM

Siding trim was damaged in one or more areas. Siding trim protects the sheathing and framing from moisture intrusion. The inspector recommends installation of siding trim for all affected areas by a licensed professional.

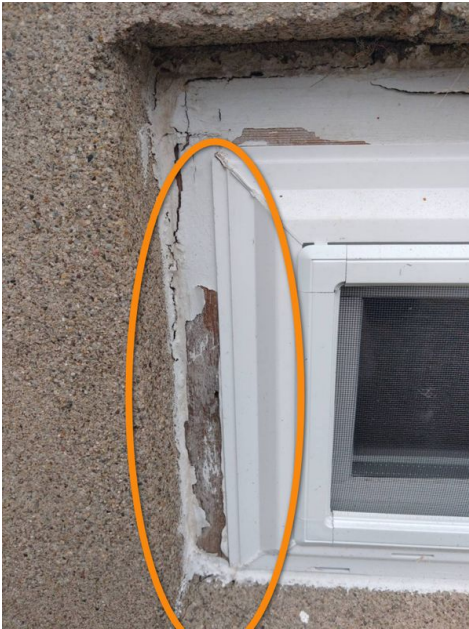
3.2.5 Siding, Flashing & Trim

DOOR OR WINDOW TRIM PAINT PEELING

One or more doors or windows had peeling paint. This could lead to rotting of the wood, moisture intrusion and/or wood destroying insect damage. The inspector recommends scraping and painting of the window or door trim by a qualified professional.

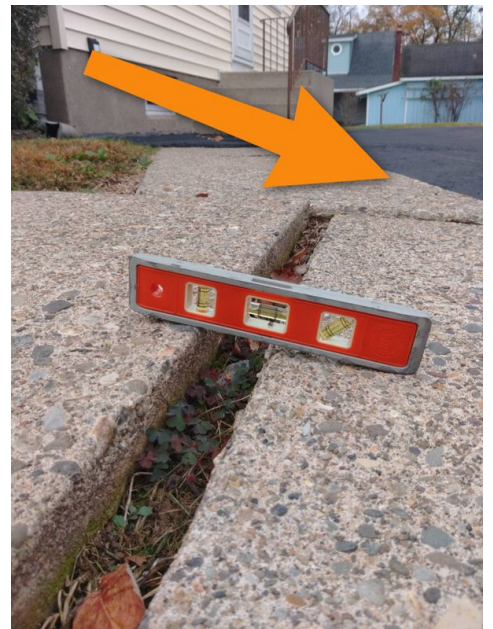
3.4.1 Walkways, Patios & Driveways

PATIO OR WALKWAY-SHIFTED/SETTLED

One or more areas of the patio or walkway have shifted and/or settled. The inspector recommends repair by a mason contractor or landscaper.

Contact a qualified masonry professional.

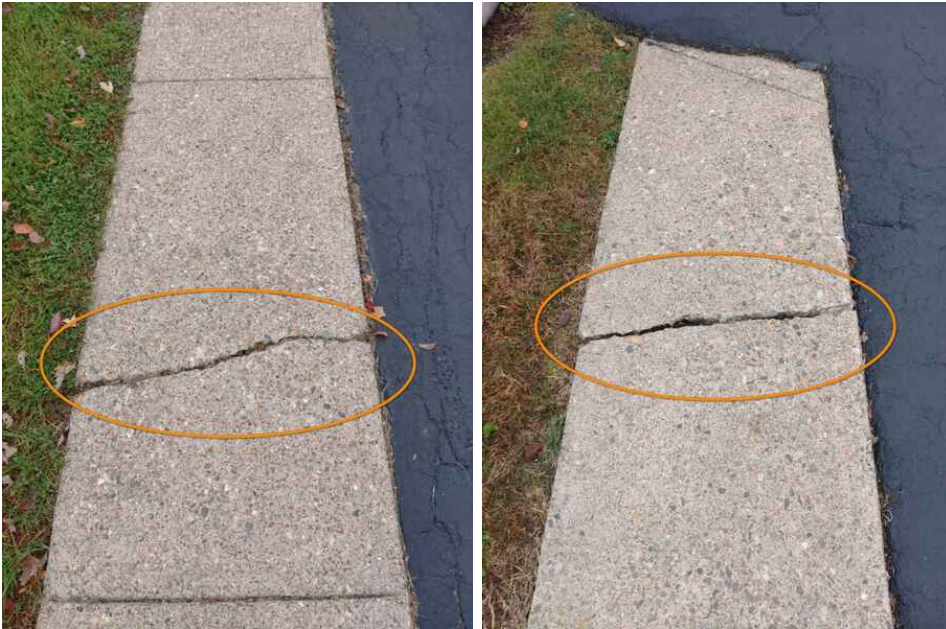
3.4.2 Walkways, Patios & Driveways

WALKWAY CRACKING - MINOR

Minor cosmetic cracks observed. Recommend monitor and/or patch/seal by a qualified masonry contractor.

Contact a qualified masonry professional.

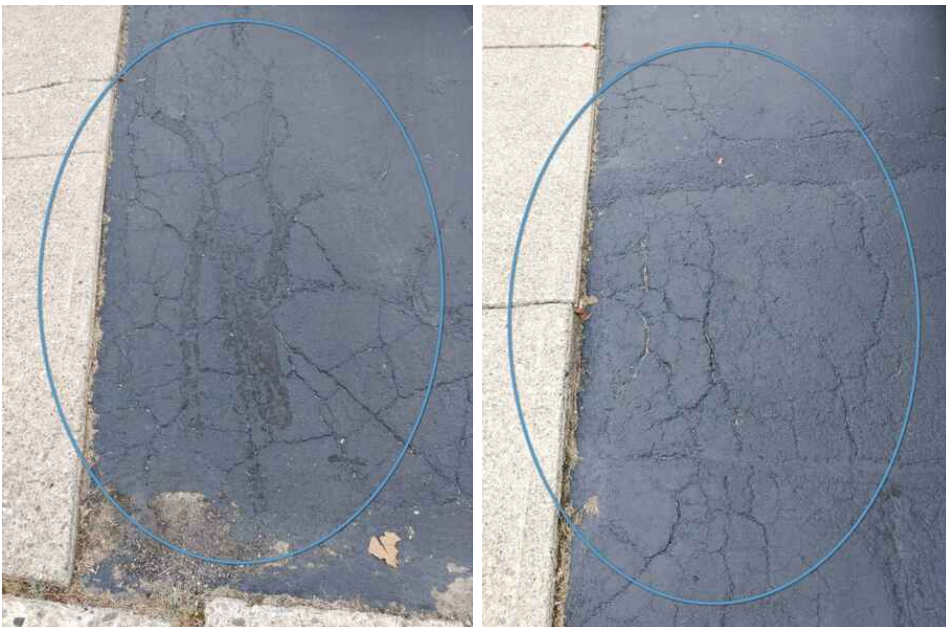
3.4.3 Walkways, Patios & Driveways

DRIVEWAY CRACKING/DETERIORATION

The driveway had cracks and had deteriorated areas at the time of the inspection. They appear to have been sealed recently but will need resealing in the future. The inspector recommends monitoring the cracks and resealing by a qualified professional when needed.

Contact a qualified masonry professional.

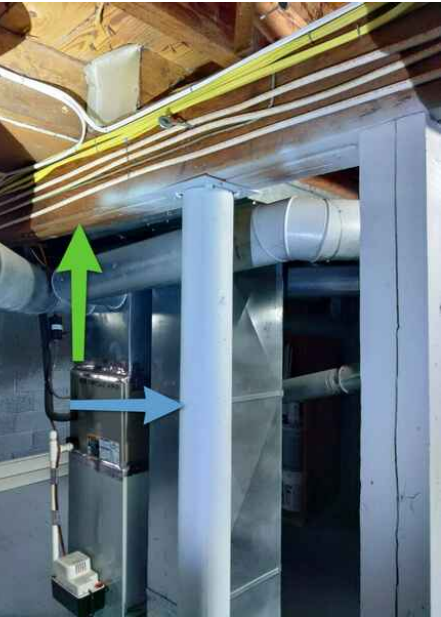
Main Beam (Green) and Support Column (Blue)

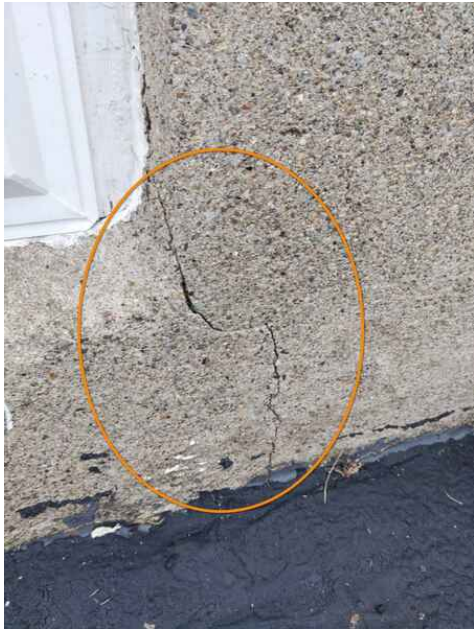
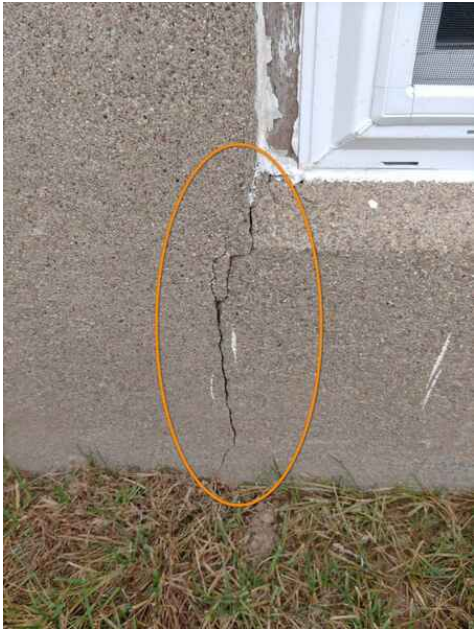
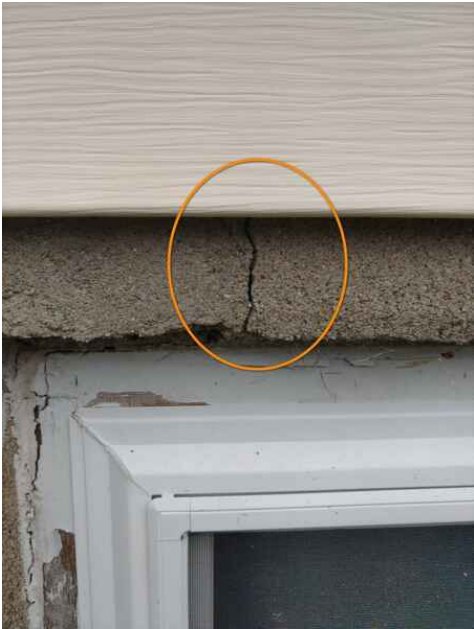
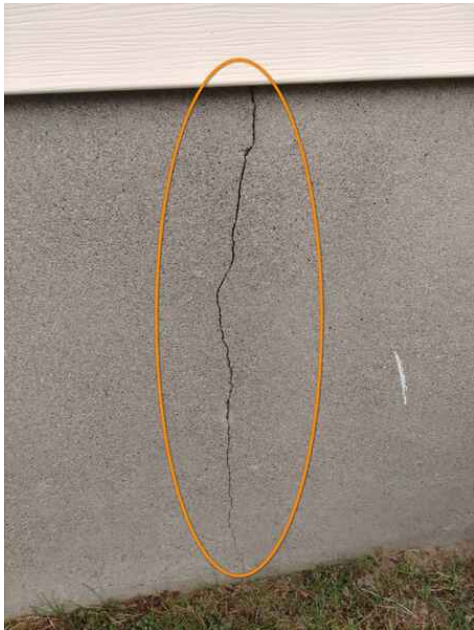
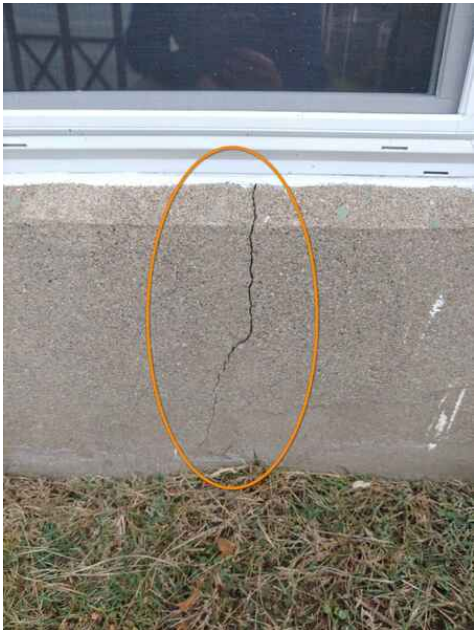
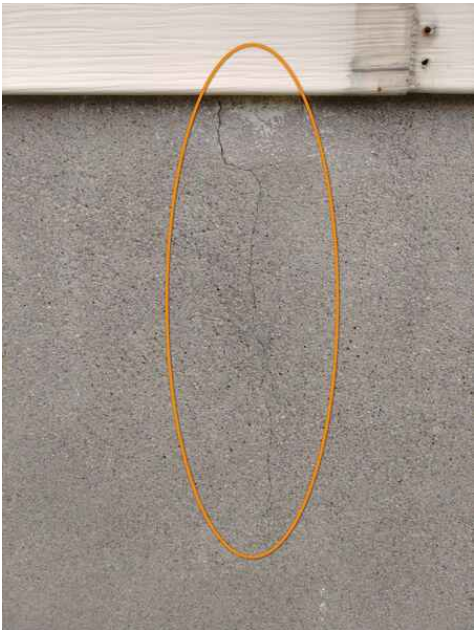
4.2.1 Foundation

PARGE COAT CRACKING

One or more cracks were observed in the masonry parge coating. Recommend monitoring the cracks for future expansion and repairs made as necessary by a licensed masonry contractor to prevent the cracks from becoming larger.

Contact a qualified masonry professional.

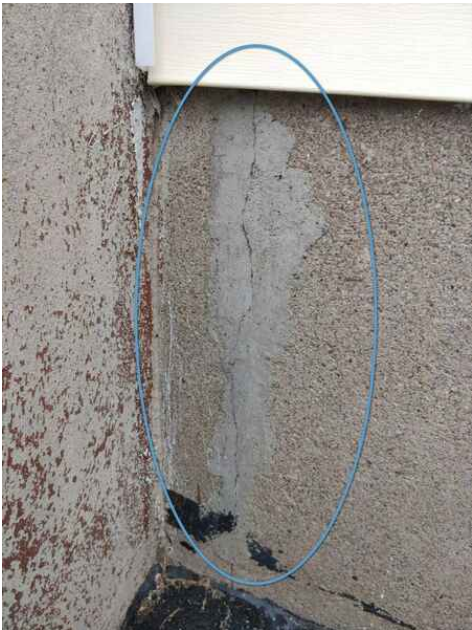
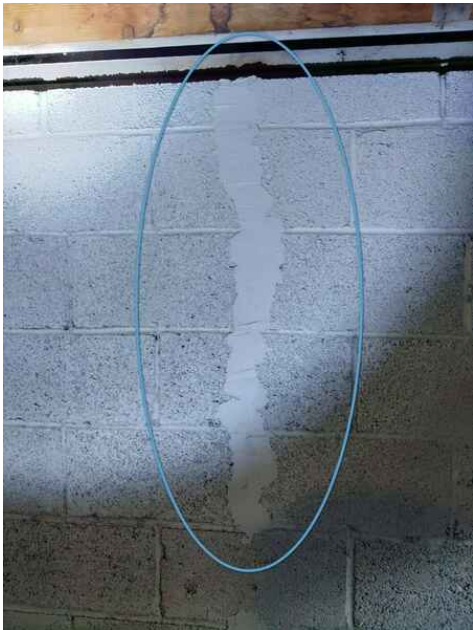
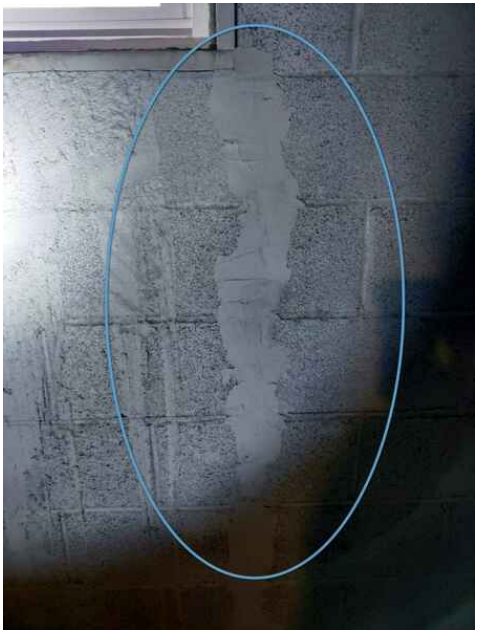
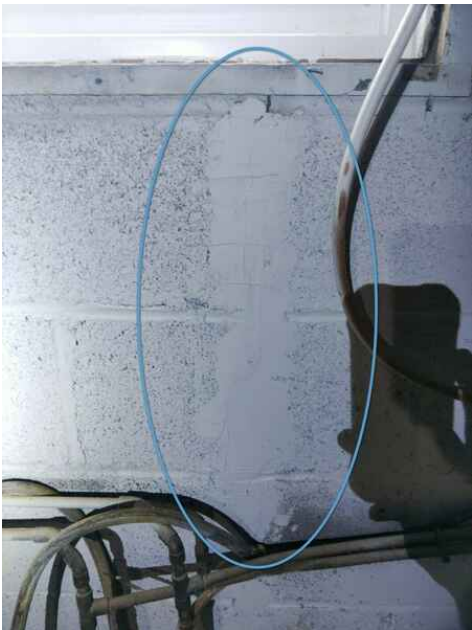
4.2.2 Foundation

EVIDENCE OF PRIOR REPAIR

One or more areas of the foundation wall showed evidence of a prior repair. Recommend monitoring the area for any water intrusion or deterioration and repair in the future as necessary by a licensed mason contractor.

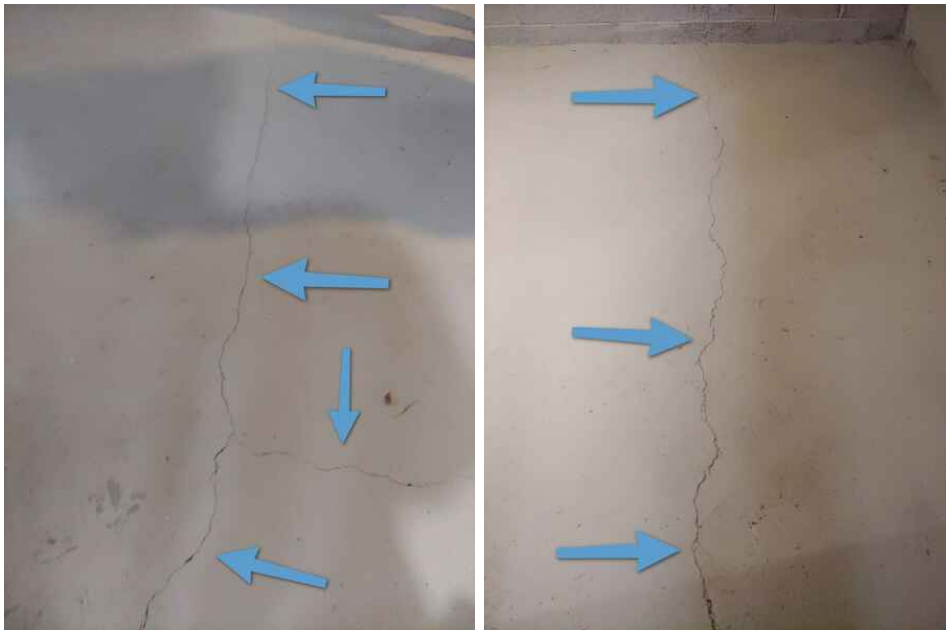
4.2.3 Foundation

COMMON CRACKS

Common cracks were visible in the basement floor. This type of cracking can have several causes

- concrete shrinkage, which is a normal part of the concrete curing process and not a structural concern
- post-construction settling due to incomplete compaction of the soil beneath the slab during construction. This also is not an unusual condition and typically would not continue.
- heaving of the soil due to the presence of expansive soils.

Contact a qualified masonry professional.

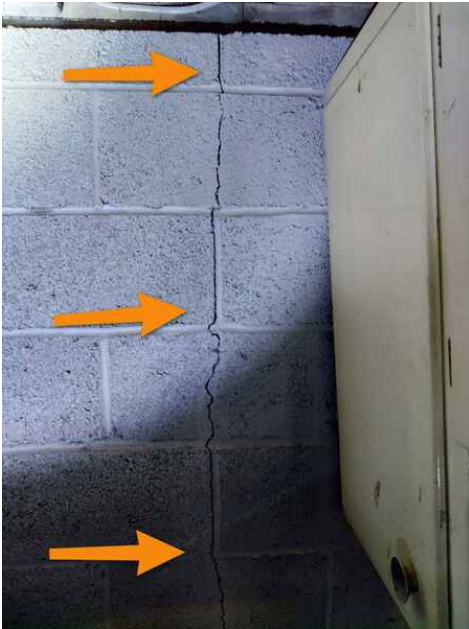
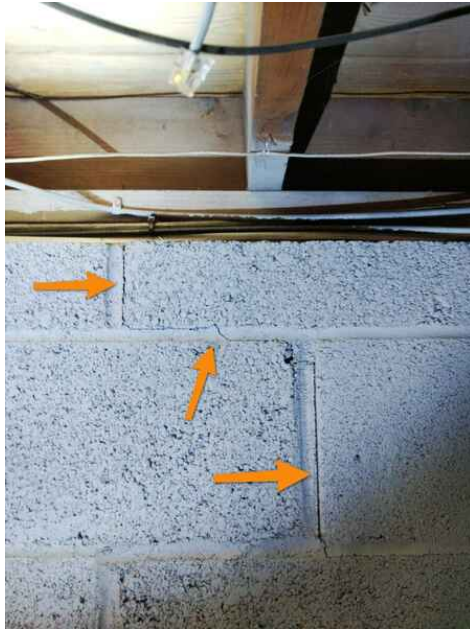
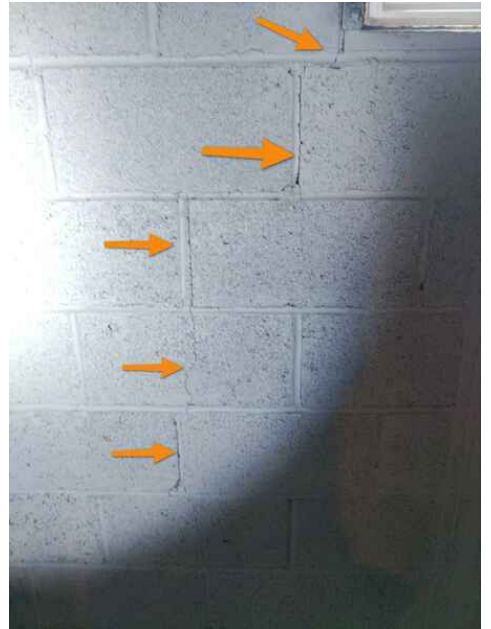
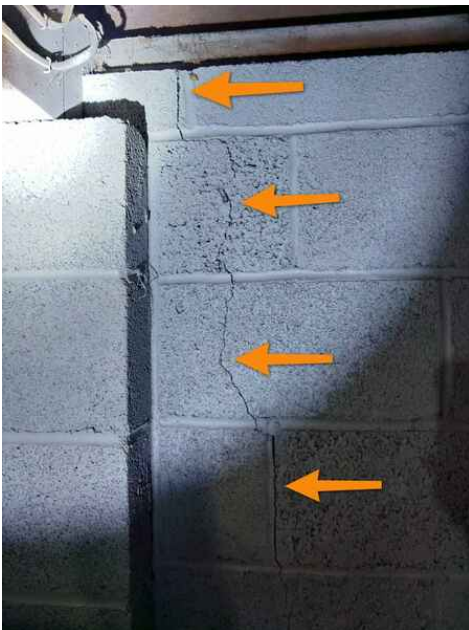
4.2.4 Foundation

MASONRY BLOCK CRACKS

Concrete Masonry Unit (CMU) foundation walls had moderate cracking visible in CMU blocks. Cracking should be patched to avoid freeze damage and the cause of cracking should be determined and corrected. Consider consulting with a qualified foundation repair contractor before the expiration of your Inspection Objection Deadline to discuss options and costs.

Contact a qualified masonry professional.

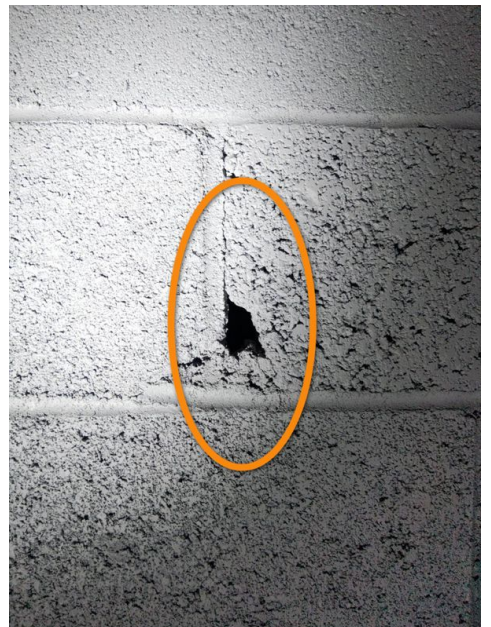
4.2.5 Foundation

HOLE IN FOUNDATION WALL

One of more foundation penetrations and/or gaps were not sealed properly. This could lead to moisture intrusion and damage to the underlayment and interior finishes of the home. Recommend having the hole repaired by a licensed contractor.

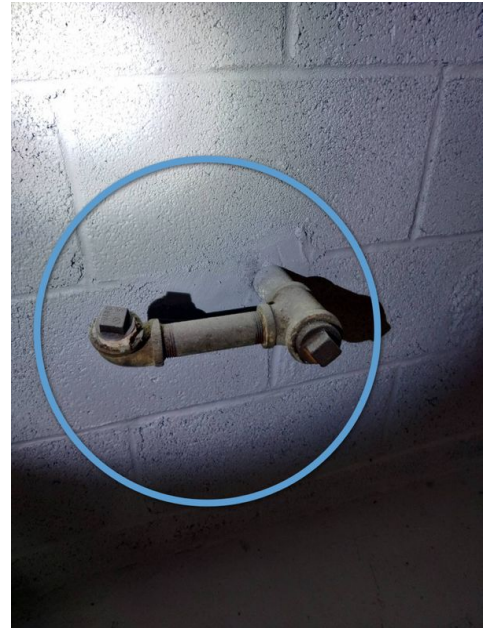
4.2.6 Foundation

UNIDENTIFIABLE PIPE

One or more pipes were observed passing through the foundation wall. The origin of the pipes could not be determined from the basement side. The inspector recommends inquiring with the homeowner to determine the previous function of the pipes or consider having a tank sweep inspection.

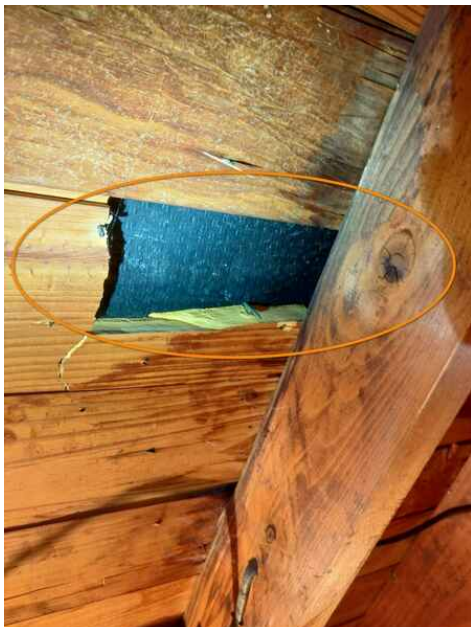
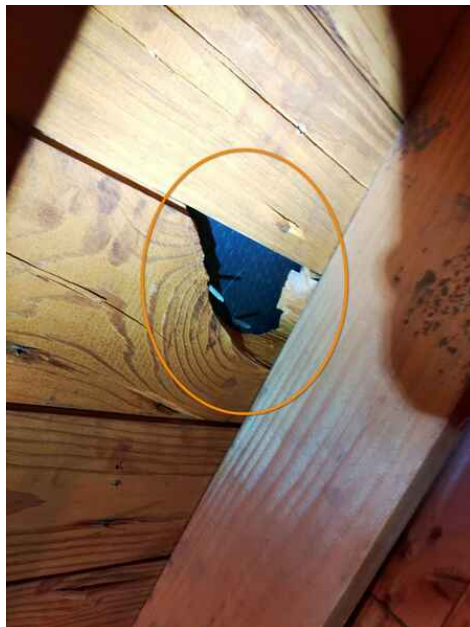
4.8.1 Roof Structure & Attic

SHEATHING DAMAGED

A portion of the roof sheathing was damaged and should be evaluated/repaired by a licensed contractor.

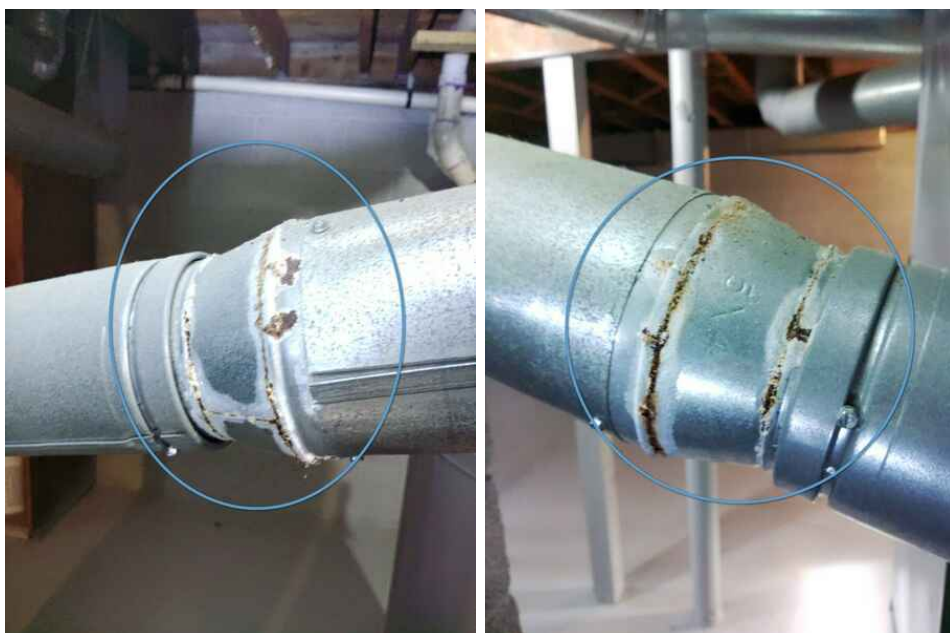
5.5.1 Vents, Flues & Chimneys

FURNACE VENT-MINOR RUST

Recommend monitoring.

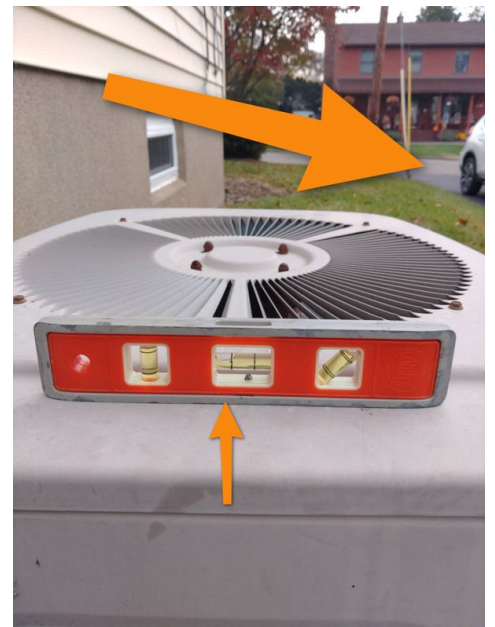
6.2.2 Cooling Equipment

UNIT NOT LEVEL

Contact a qualified HVAC professional.

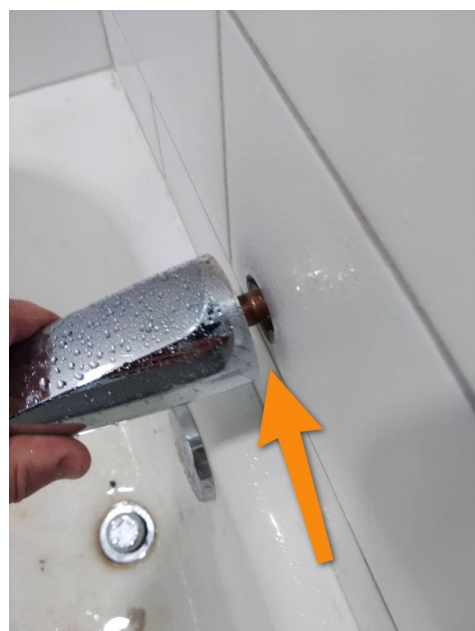
7.5.1 Kitchen & Bathroom Fixtures

TUB SPOUT LOOSE

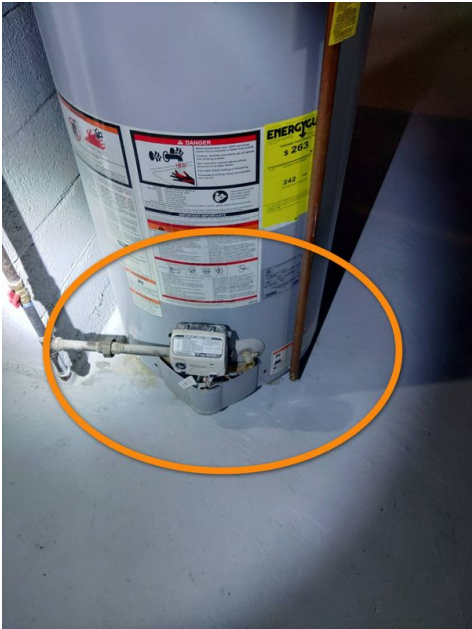
7.6.1 Hot Water Systems, Controls, Flues & Vents

NO DRIP PAN

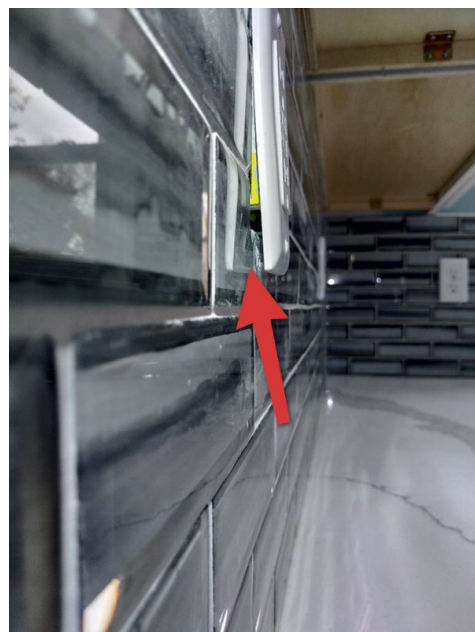
8.5.2 Lighting Fixtures, Switches & Receptacles

LOOSE OUTLETS/SWITCHES

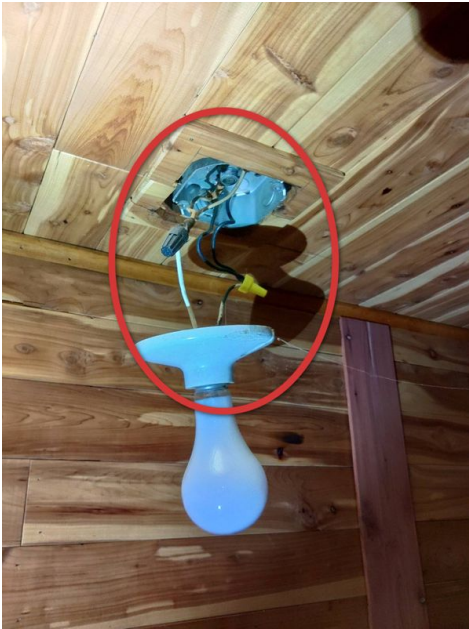
8.5.3 Lighting Fixtures, Switches & Receptacles

LIGHT FIXTURE IMPROPERLY INSTALLED

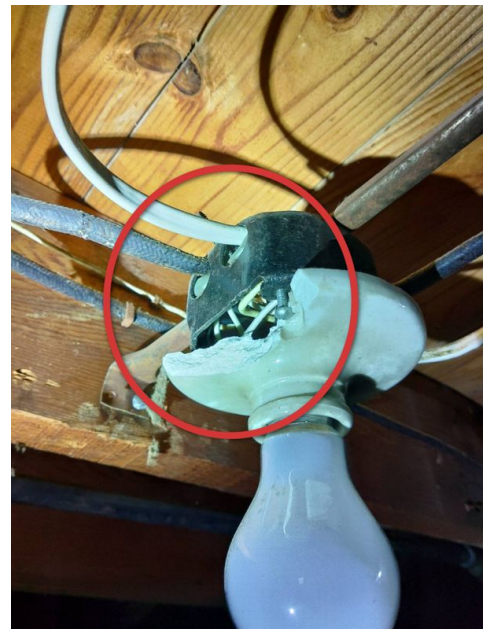
8.5.4 Lighting Fixtures, Switches & Receptacles

DAMAGED LIGHT FIXTURE

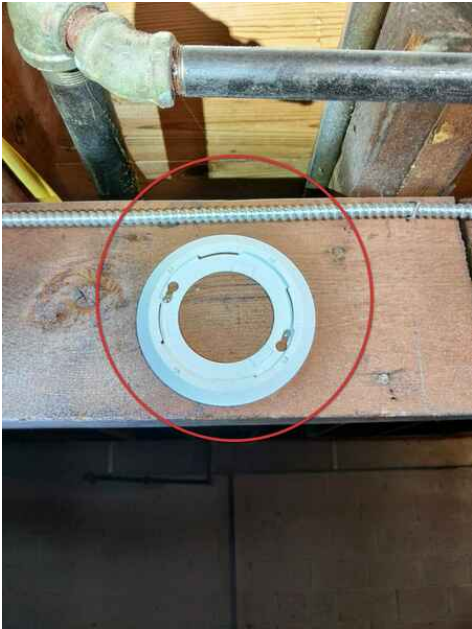
8.7.1 Smoke Detectors

SMOKE DETECTORS MISSING

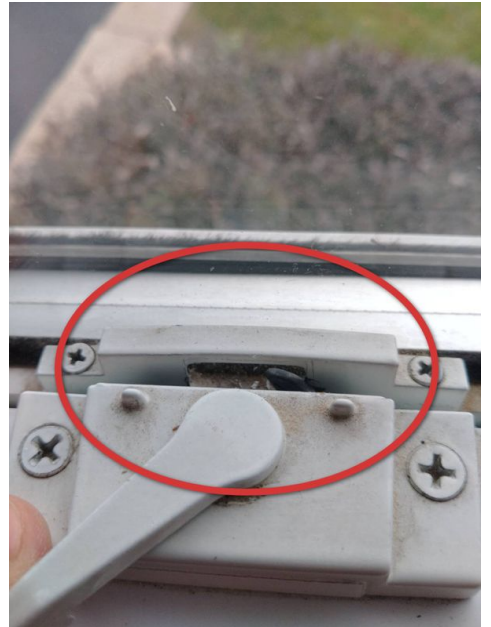
10.3.1 Windows

**WINDOW LOCKS
INOPERATIVE/DAMAGED**

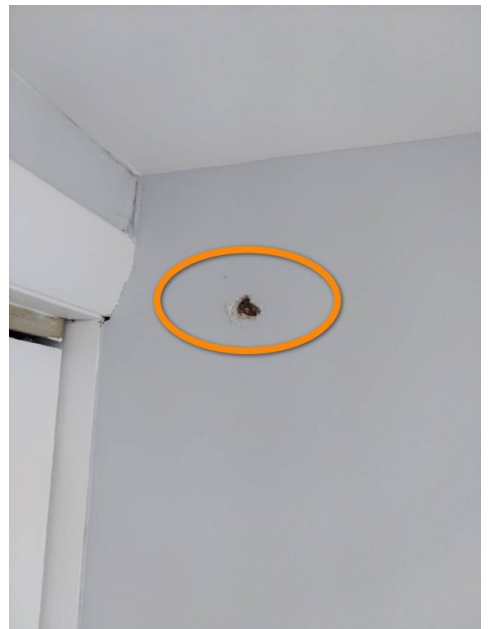
10.5.1 Walls

DRYWALL-HOLE

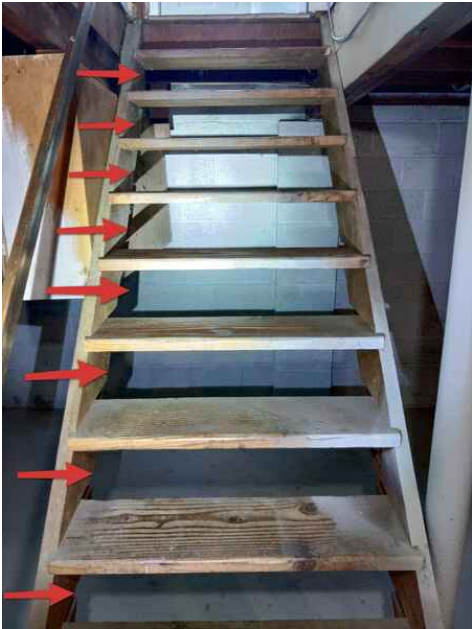
10.7.1 Steps, Stairways & Railings

OPEN RISERS
